The 'Umka' landslide

We present an in-depth landslide map of the 'Umka' landslide near Belgrade, Serbia, at a scale of 1:5000. The map delineates elements at risk, primarily buildings and road infrastructure impacted by the landslide displacements of several cm per year, introduced during frequent reactivation stages. The Main map results from a survey of over 350 buildings and more than 7 km of state and local roads. The acquisition techniques included engineering geological field mapping, building survey, and visual interpretation of high-resolution UAV images. This is the first case of an integrated approach to mapping elements at risk within an urbanized active landslide in Serbia. Presently, over 490 people continue to reside at the site, facing daily landslide risks. This research and map hold substantial value for local authorities and decision-makers, providing a basis for conducting landslide risk analyses and implementing effective risk mitigation strategies or remedial measures.

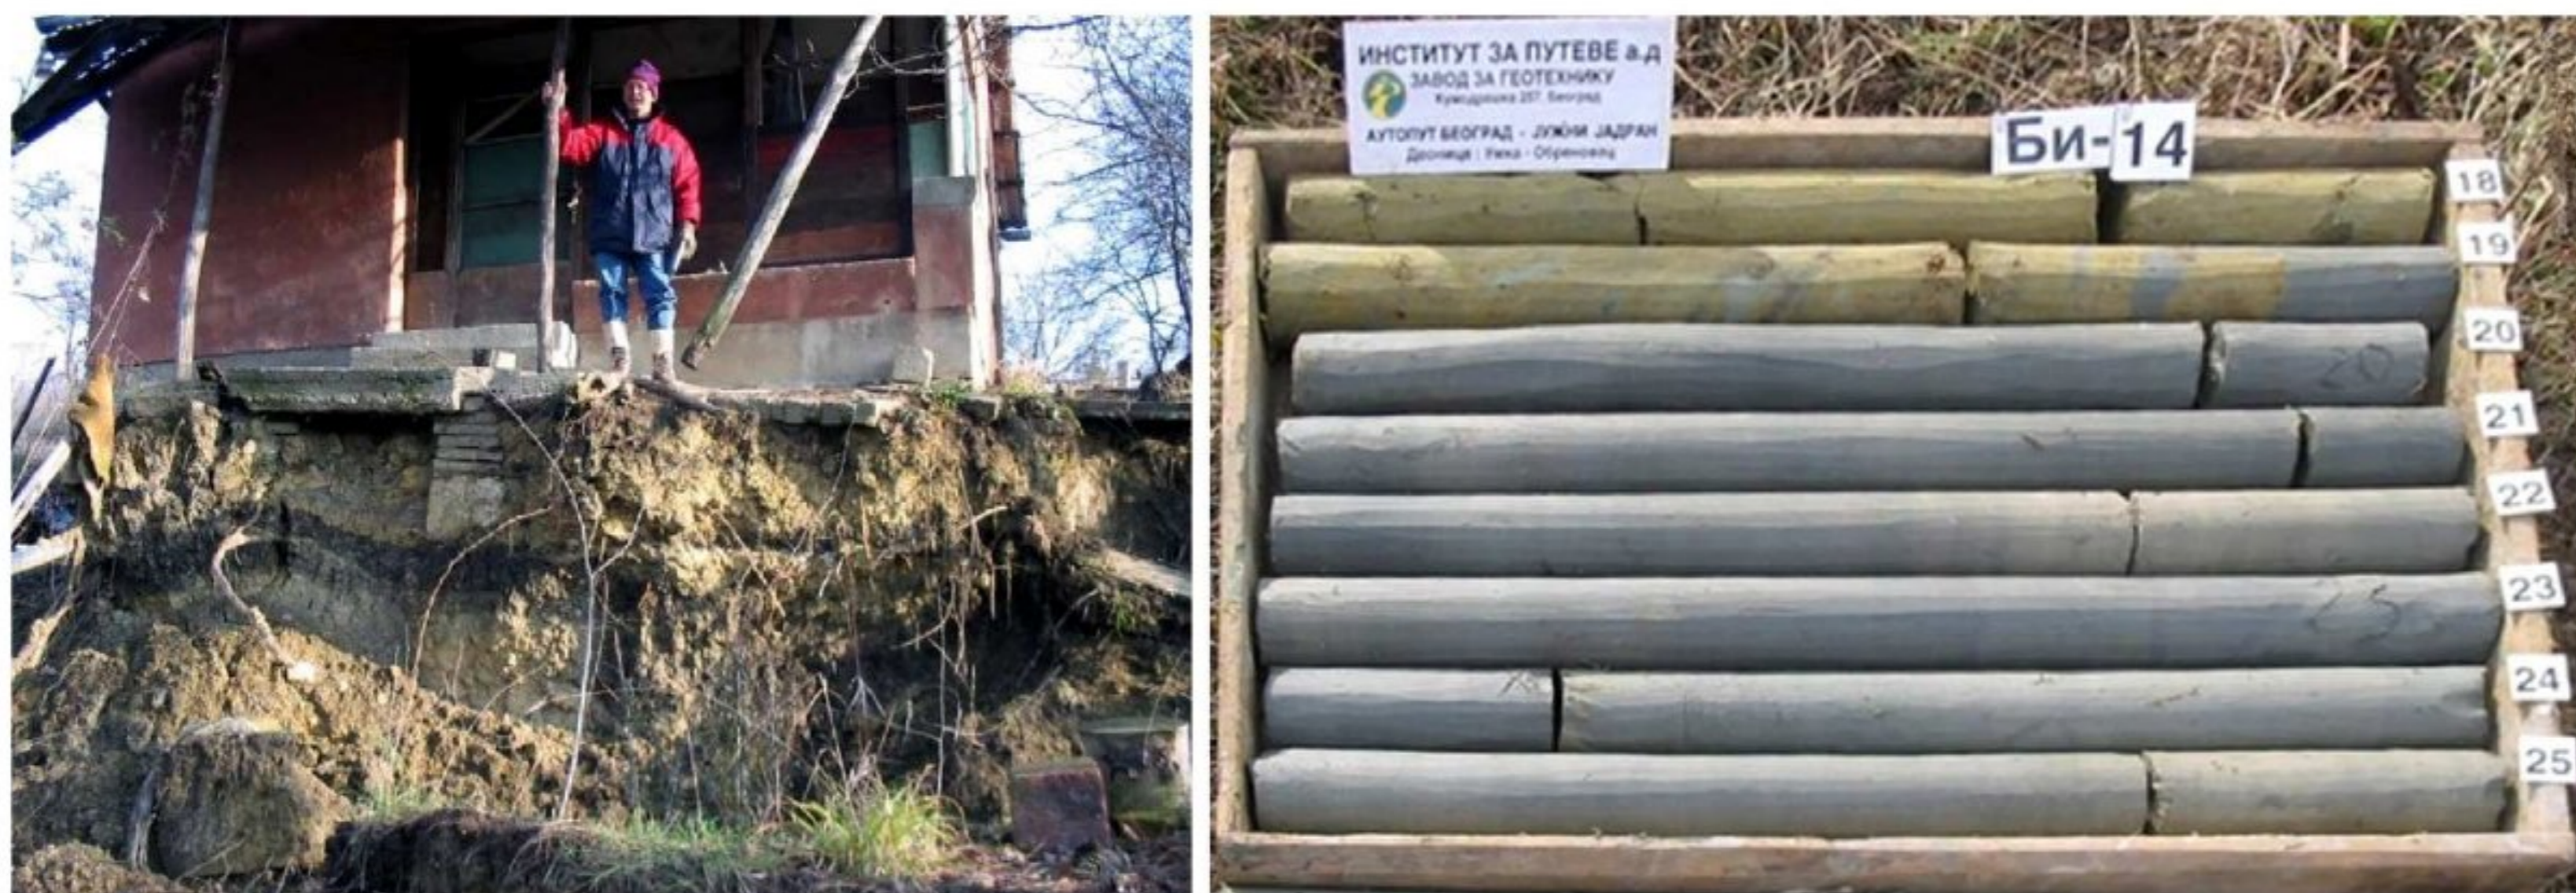
Figure 1. Field images of outcrops on the face of a secondary landslide scar, with typical remolded material with heterogeneous lenses and undulating interfaces (left); and the core box of borehole Bi 14, where interface of fresh marl and remolded clay marl, representing the slip surface, is visible (right); Photo by Svetozar Milenković.

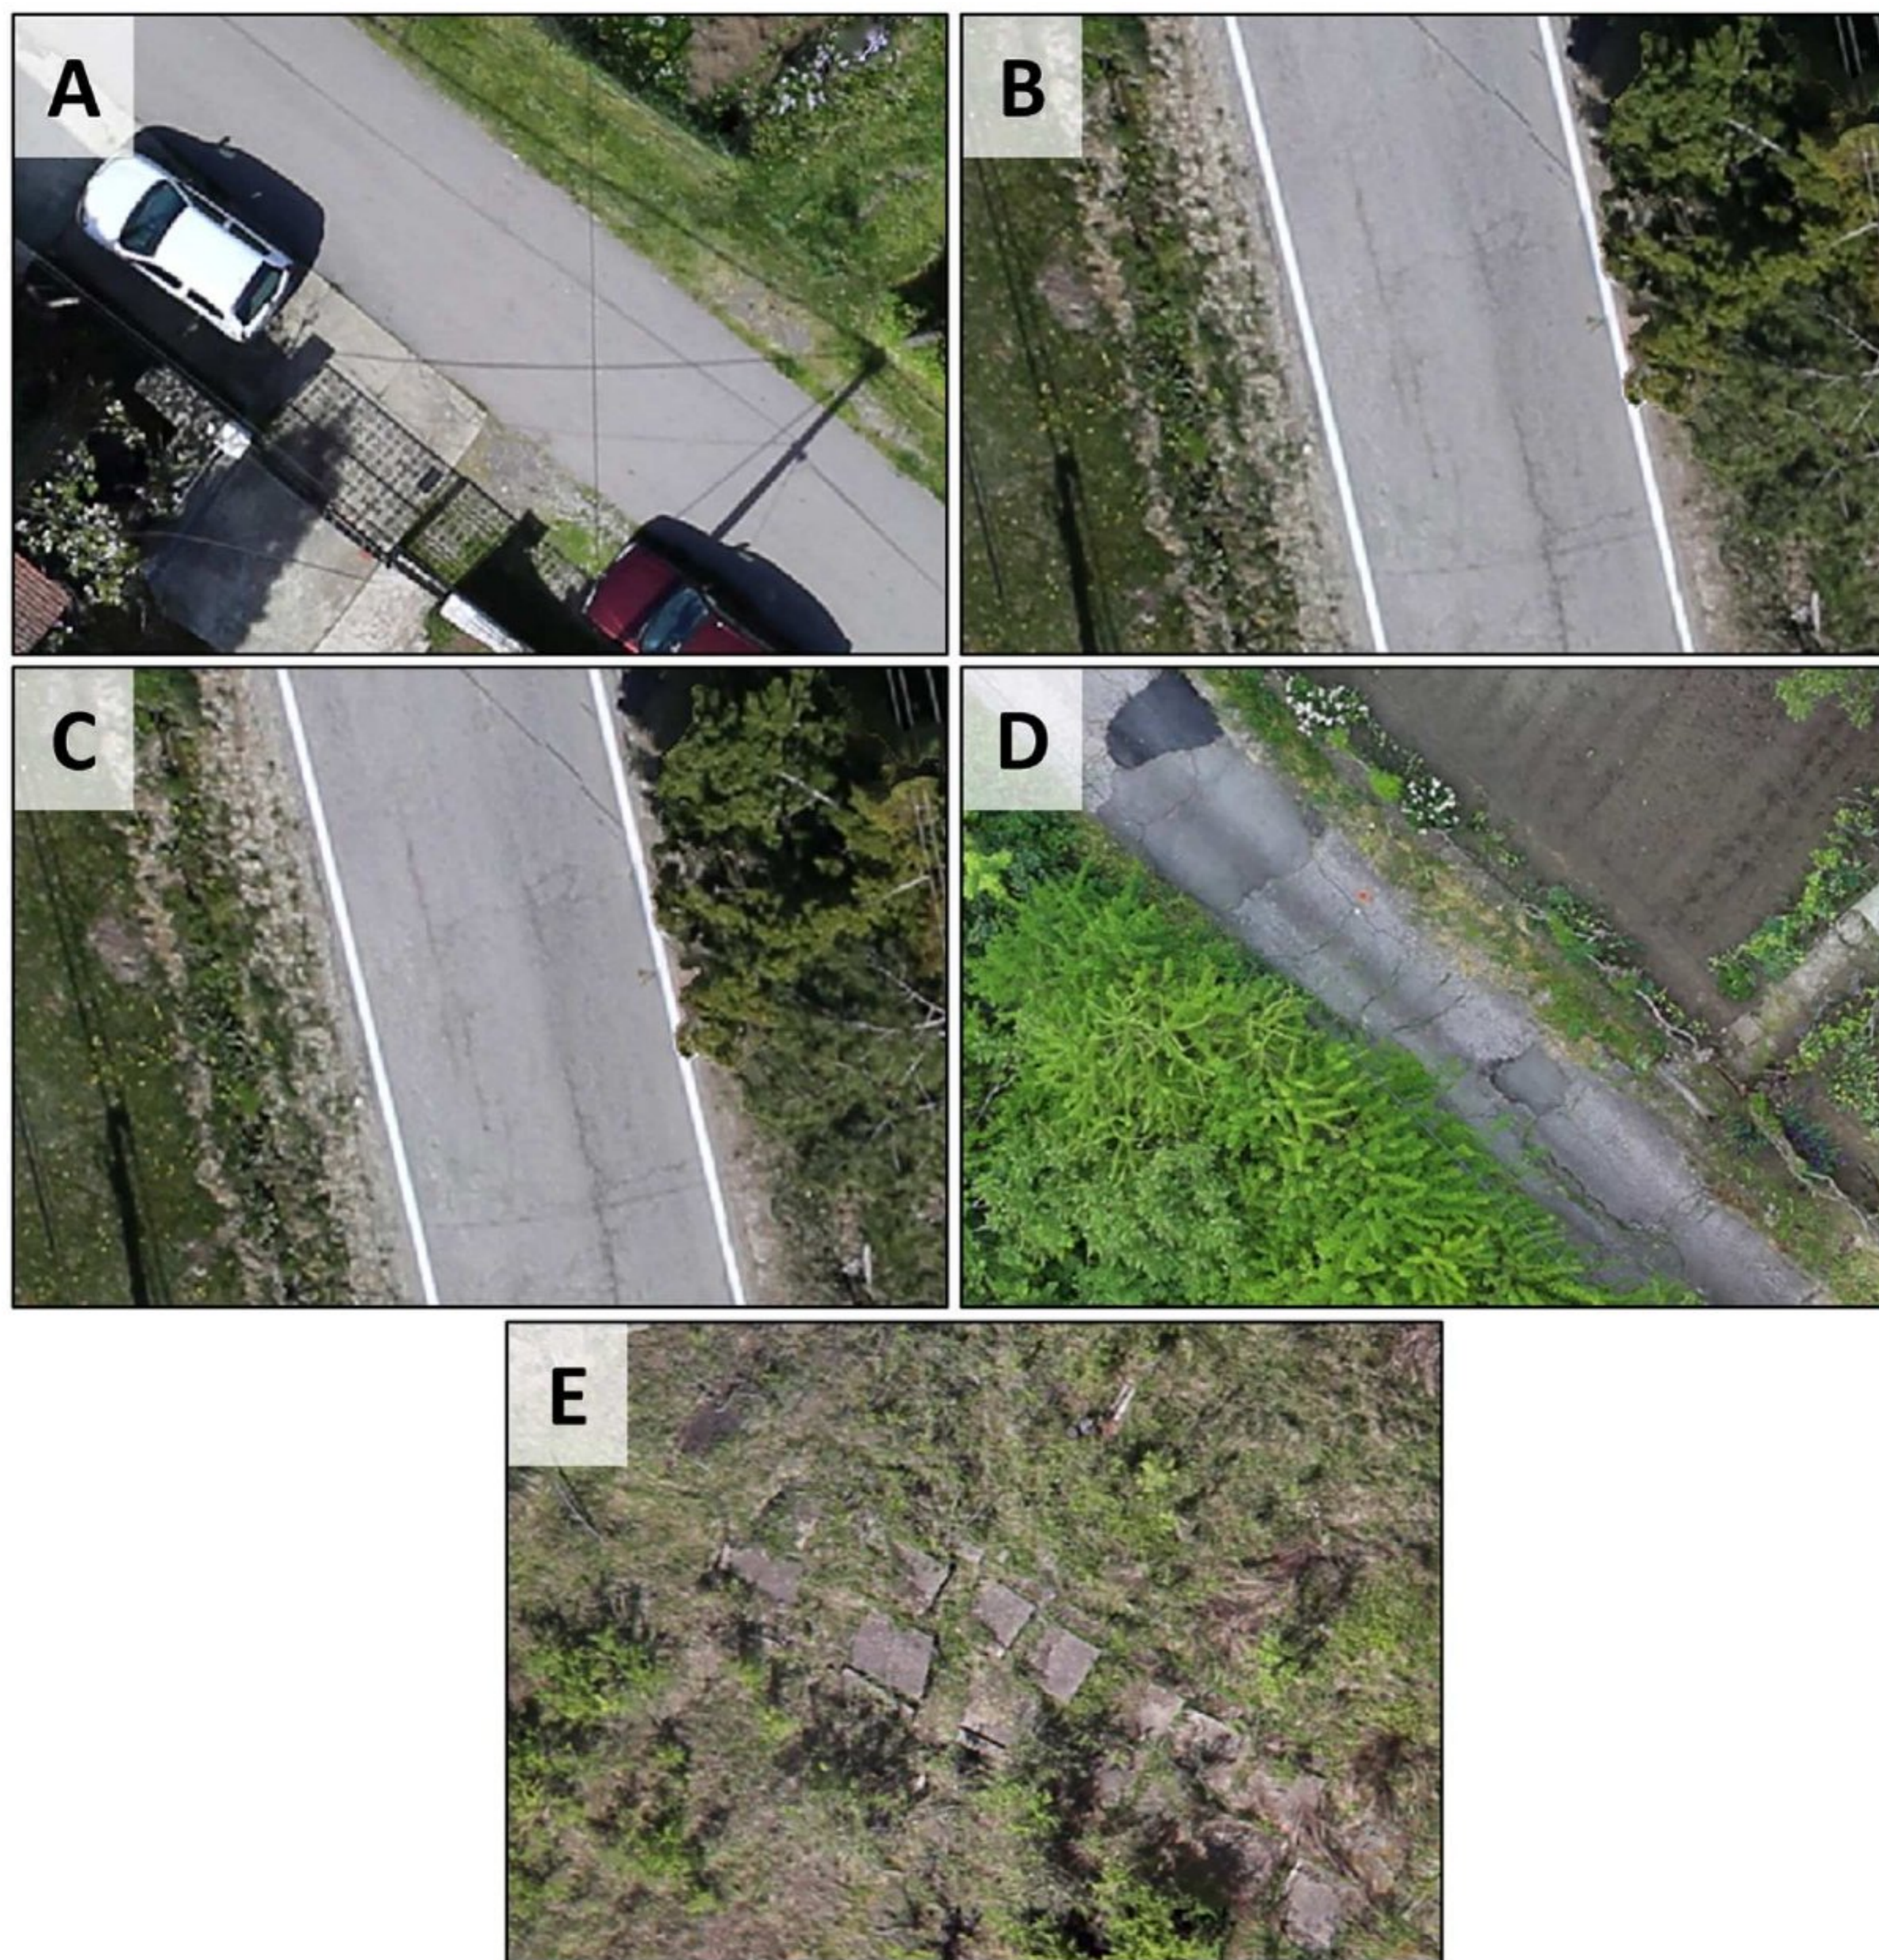
The categorization of damage was primarily based on the assessment of the actual road surface damage, which was visible from orthophotos (Figure 2). The condition of the road structure itself, which was only present on state road N°26, was verified through field inspections. Each road was divided into segments by deformation, ranging from 'no damage' to 'permanently destroyed', based on a qualitative description,

Figure 2. Details of roadway infrastructure based on the criteria outlined in Table 2: (A) Road without damage; (B) Slightly damaged road; (C) Damaged Road; (D) Heavily damaged road; (E) Destroyed Road.

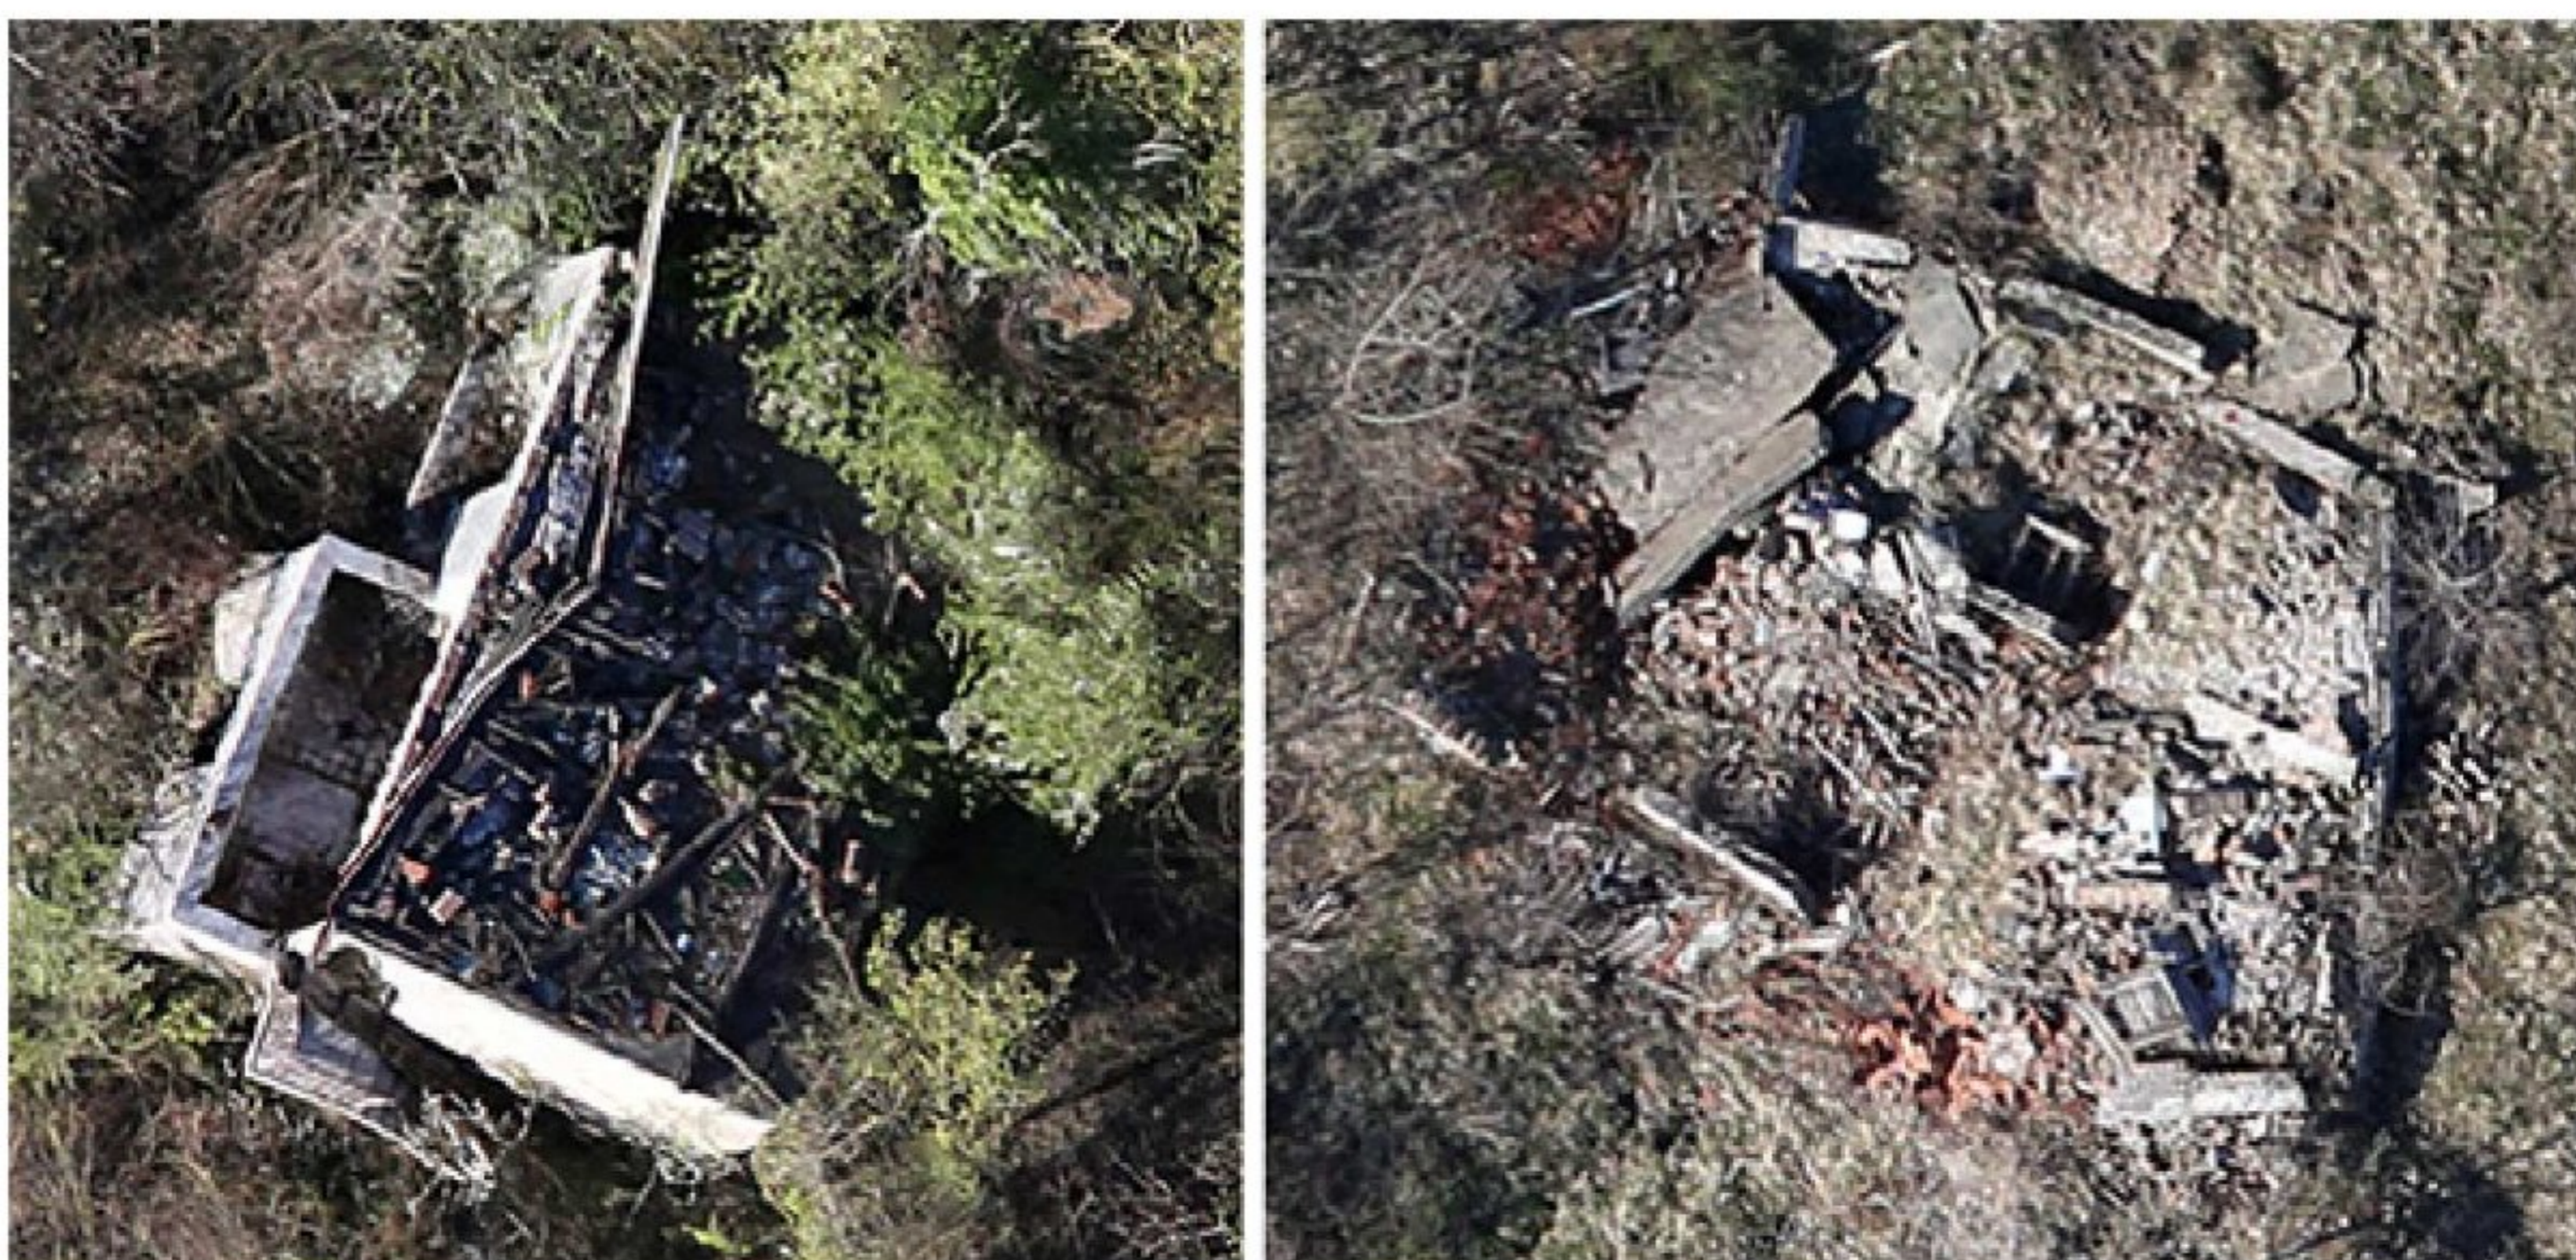
questionnaire was made. As many as 18 buildings in the landslide area are no longer physically located in their original positions. These buildings were mapped using remote sensing techniques (Figure 3), based on archival or newly captured aerial photographs. For these buildings, attributes were recorded to a level that was possible using only visual identification as a tool. For example, it was possible to recognize the type of roof covering, the useful square footage of the base of

Figure 3. Aerial images of two destroyed buildings on the 'Umka' landslide that are inaccessible and surveyed by UAV remote sensing.

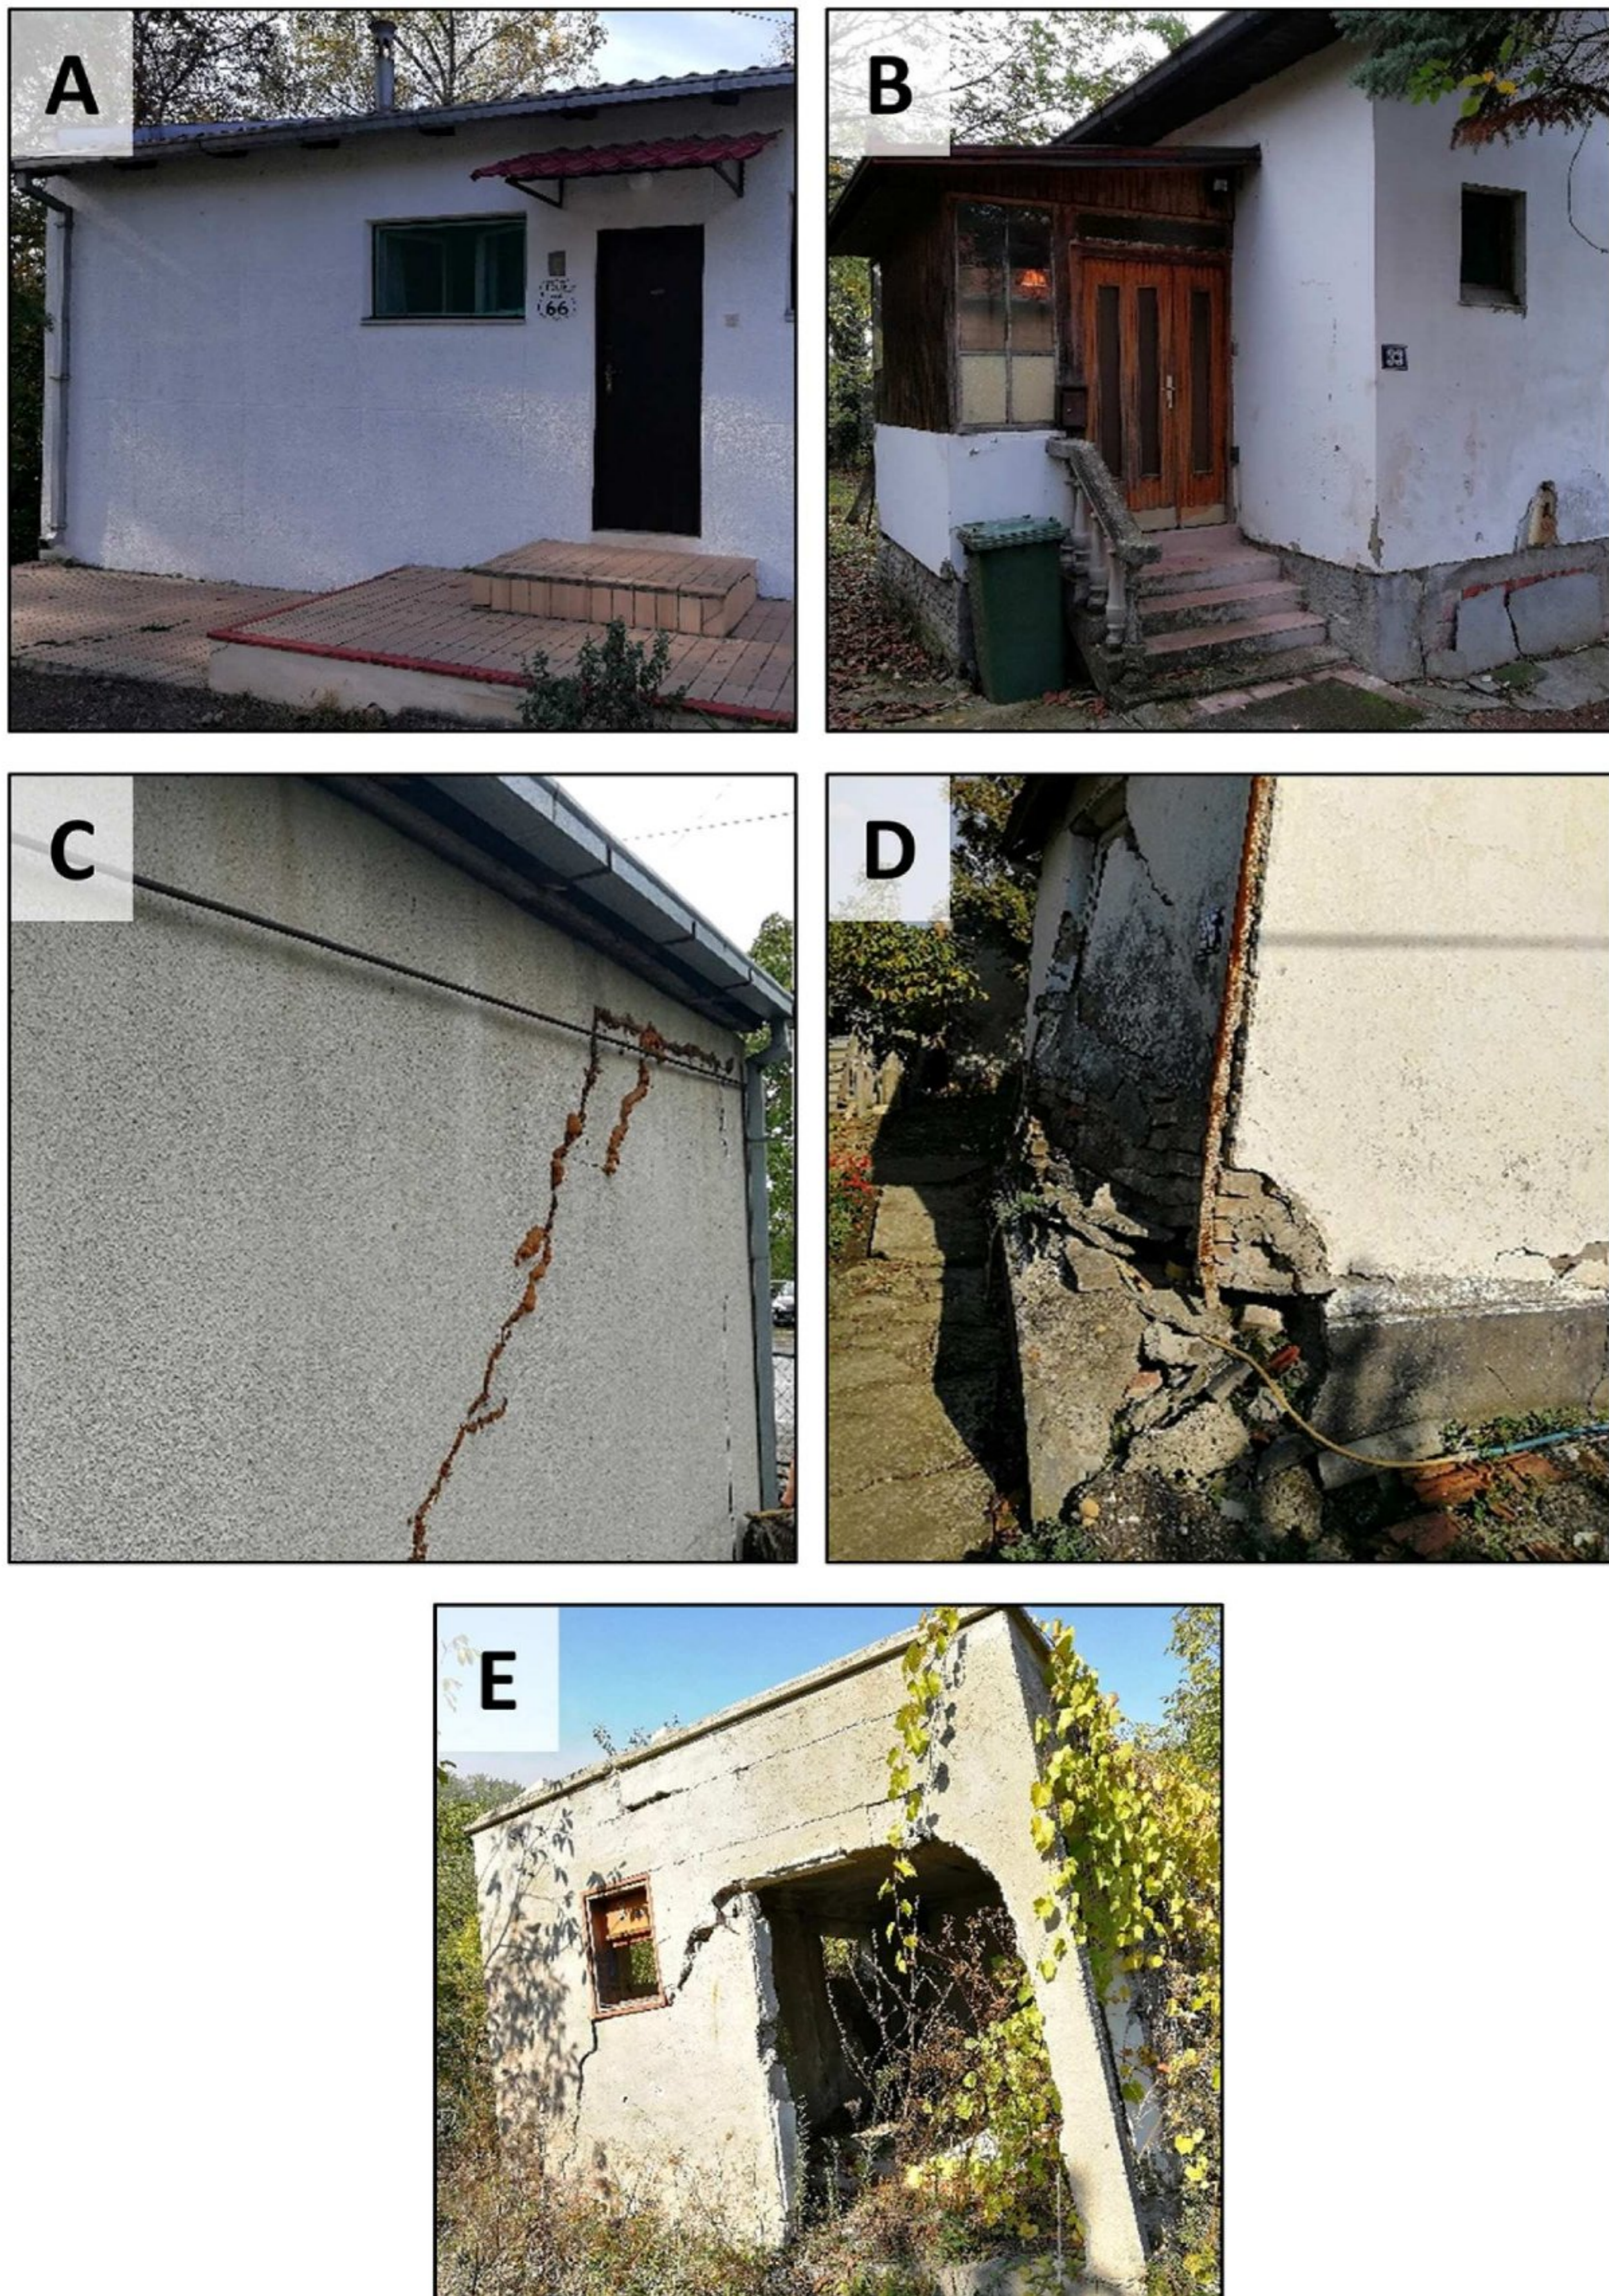
Figure 4. Photographs of selected buildings on the ‘Umka’ landslide by damage category based on the criteria outlined in Table 1: **(A)** Building without damage; **(B)** Slightly damaged building; **(C)** Damaged building; **(D)** Heavily damaged building; **(E)** Destroyed/ Collapsed building.

Results of the building survey showed that only 69 (18%) buildings were without any deformation and 90 (24%) buildings had slight damage from the landslide. 100 (27%) buildings were classified as damaged and 74 (20%) as heavily damaged while 42 buildings were identified as damaged or destroyed.

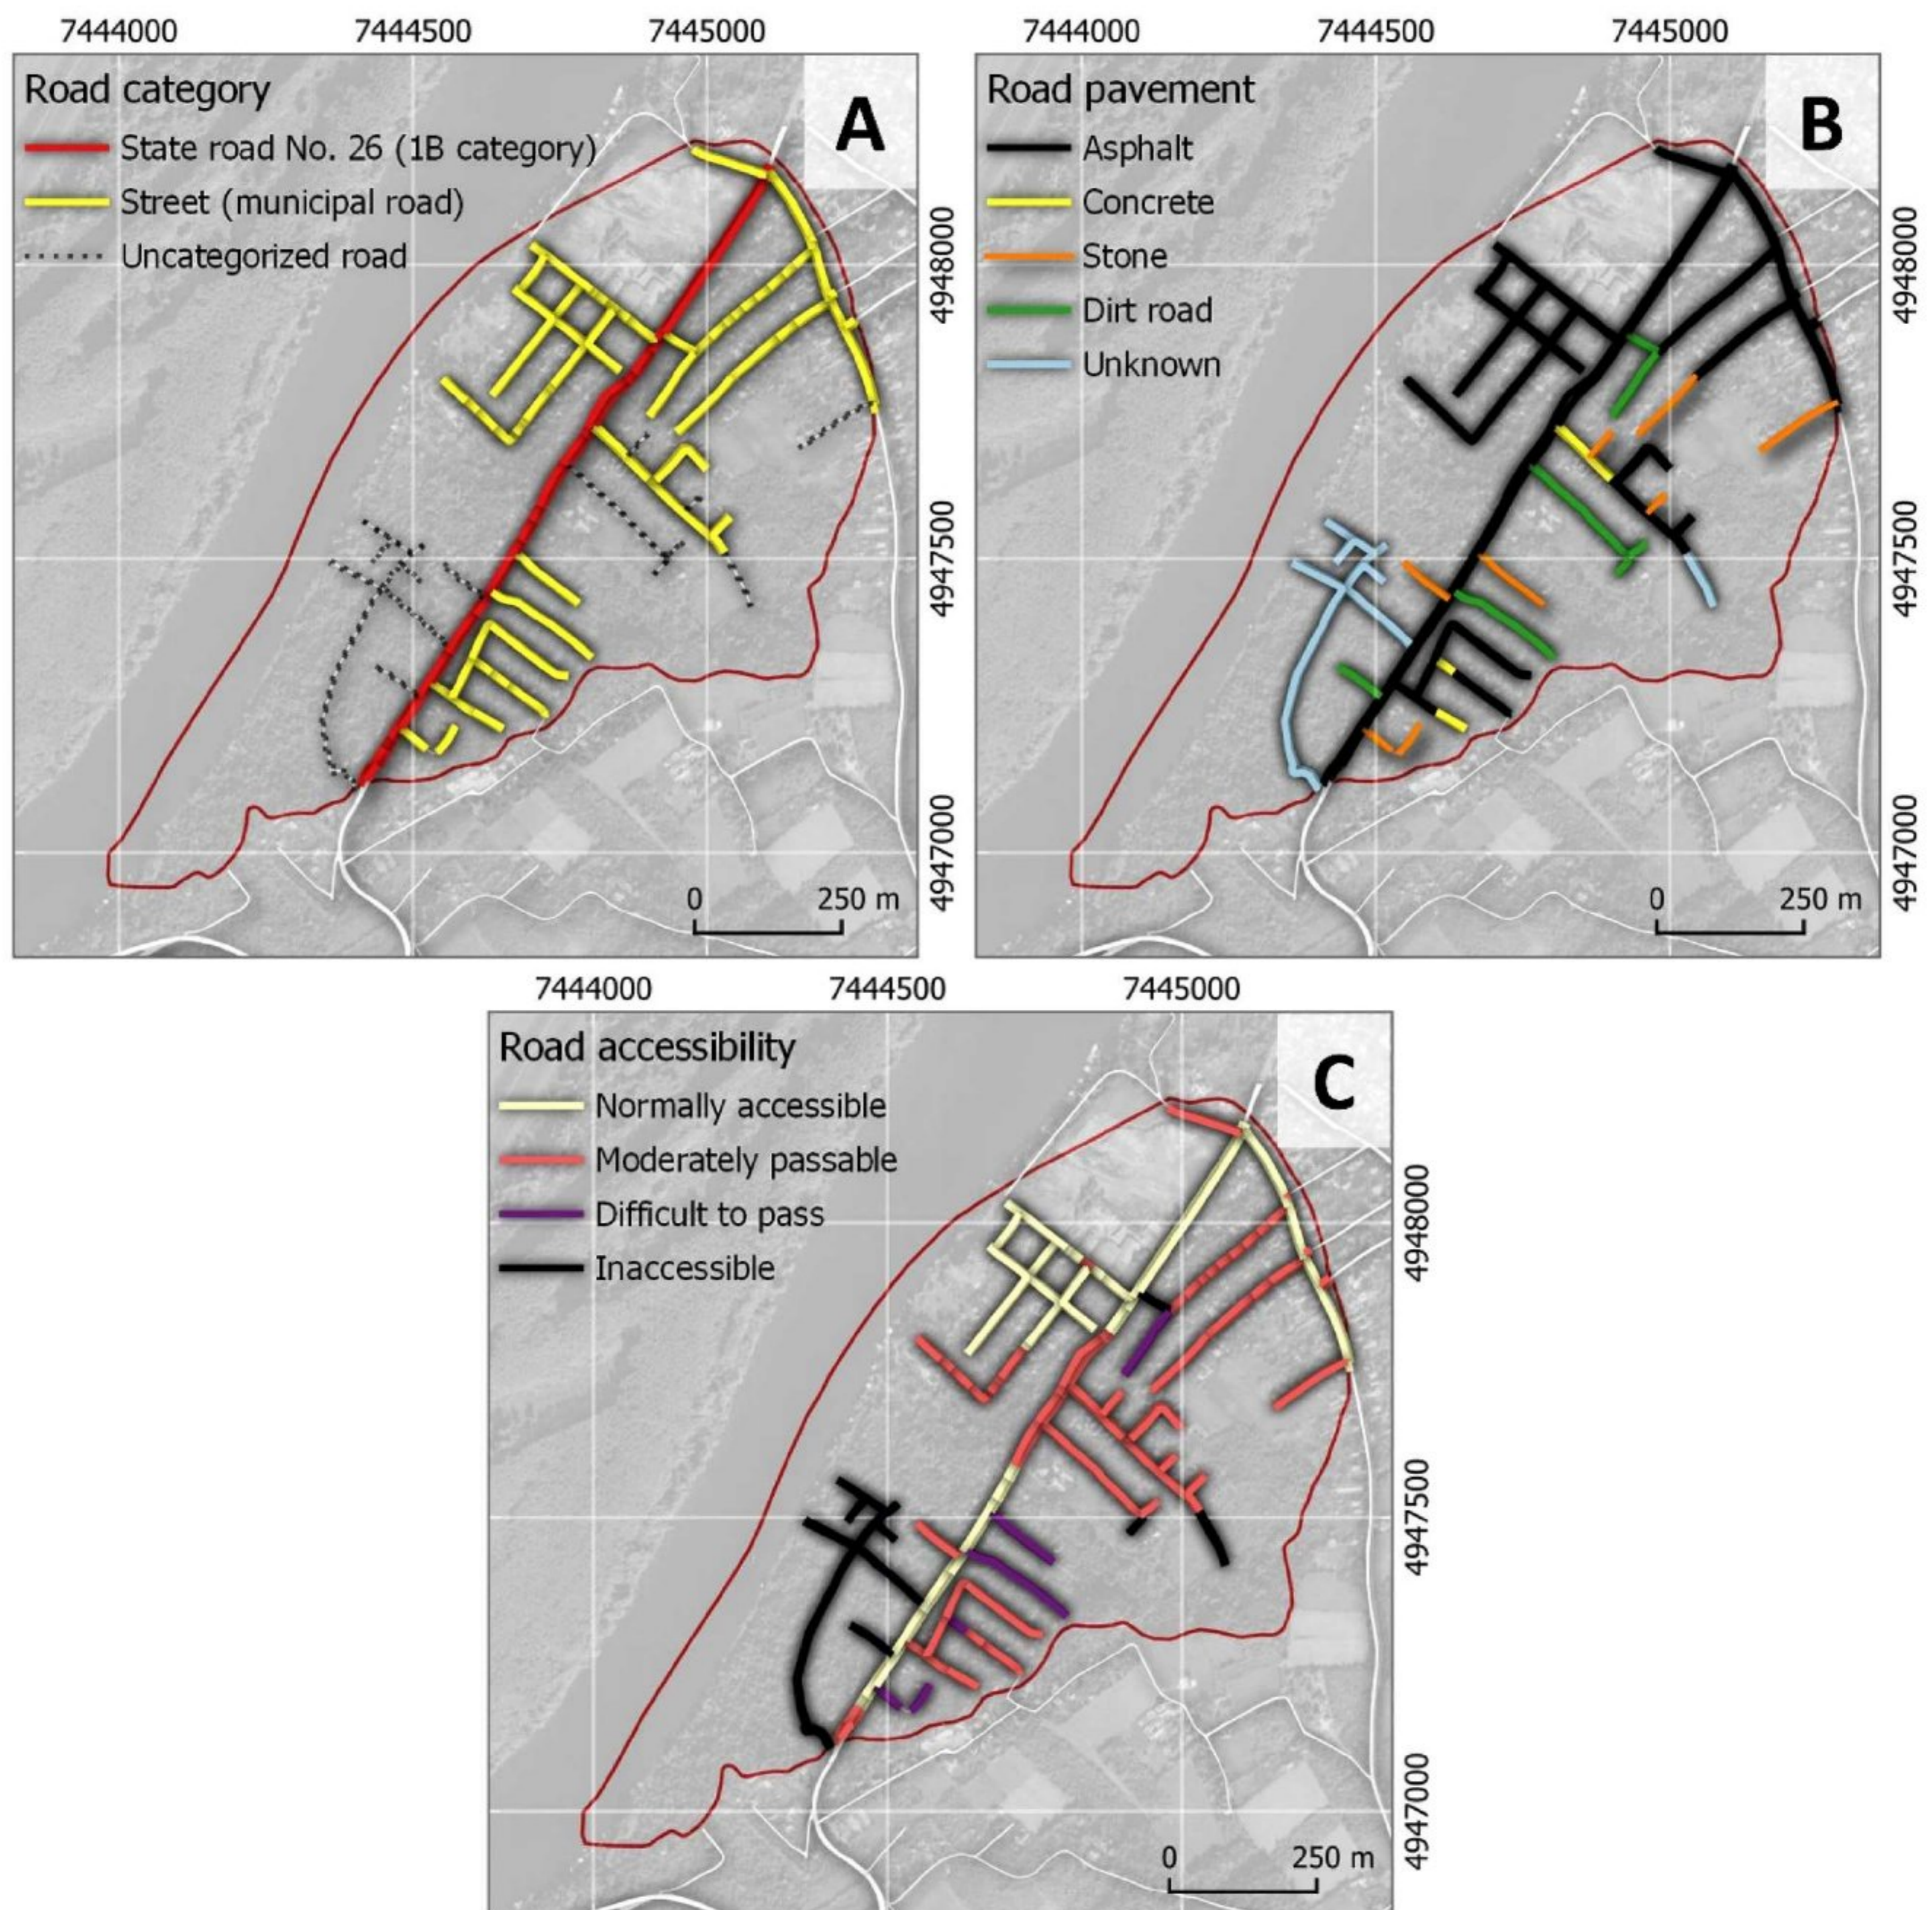
Figure 5. (A) Road category map of the 'Umka' landslide; (B) Road pavement map of the 'Umka' landslide; (C) Road accessibility map of the 'Umka' landslide.

The landslide 'Umka' crosses a total of 7.1 km of roads of various categories, as shown in Figure 5A. The most prevalent type of road within the landslide area is streets (municipal roads), which account for 4.15 km

Based on the material of the pavement within the ‘Umka’ landslide, the road surface is mostly comprised of asphalt (Figure 5B) with a total length of 4.4 km (61%). Dirt roads account for 0.8 km (11%), followed by stone pavement, which has a total length of 0.7 km (9.9%). Concrete is the least represented, accounting for 0.2 km (3.1%). It was not possible to determine the type of material for the 1 km (15%) of roads that have been destroyed (classified as Unknown).

In terms of accessibility, 2.2 km (31%) of the roads are considered normally accessible, 3 km (44%) are moderately passable, 0.6 km (8%) are difficult to pass, and 1.2 km (17%) are inaccessible. The map of traffic roads is illustrated in (Figure 5C).

The analysis further showed that only 38% of the roads are undamaged or have minor damage, while 62% are damaged, significantly or completely, preventing their regular use. The biggest risk is the deformation of the state road N°26, which significantly slows down the traffic and affects its safety, thus preventing safe access and regular use of the street infrastructure for most of the residents.
