FORMATION OF THE RISK MODEL AT THE INTERNAL LANDFILL OPEN MINE PIT "TAMNAVA-WEST FIELD"

Preliminary Communication
DOI: 10.5937/RGD240013B

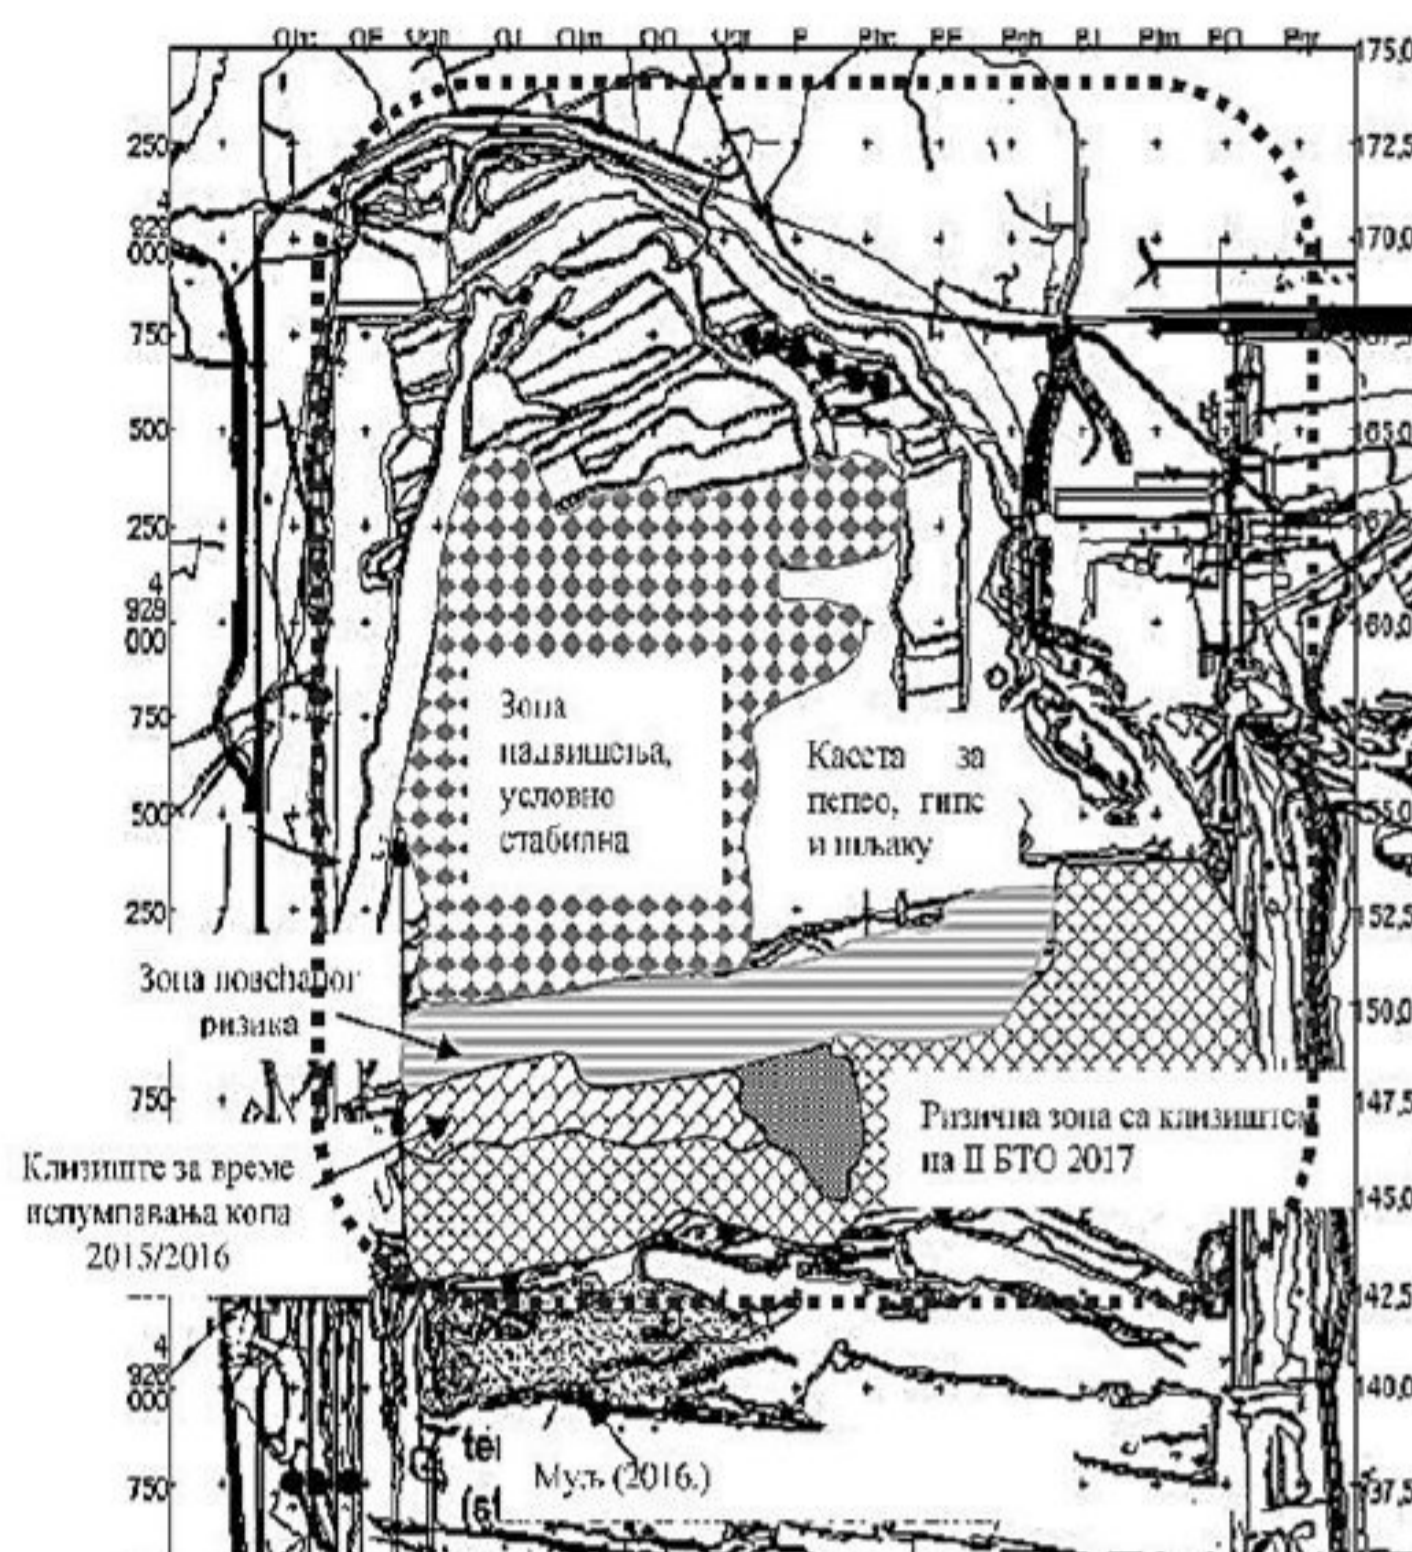
Figure 2, Disposition of zones with different levels of risk

For easier understanding and explanation of the problems in the field, Figure 2 gives the disposition of zones with different levels of risk, degree of mining activity and the size of deformations, which were registered during pumping water from the mine (landslide, sludge zone).

In November 2014, with the water level dropping by 20 m, the deposited, unconsolidated allurites in the "coastal" slopes became unstable. The moving masses endangered the planum along which the construction of the "Radljevo" corridor is planned. A new landslide was then formed in 2017 on the II ETD system (Figure 2). This time, the cause of the instability was the disposal technology.

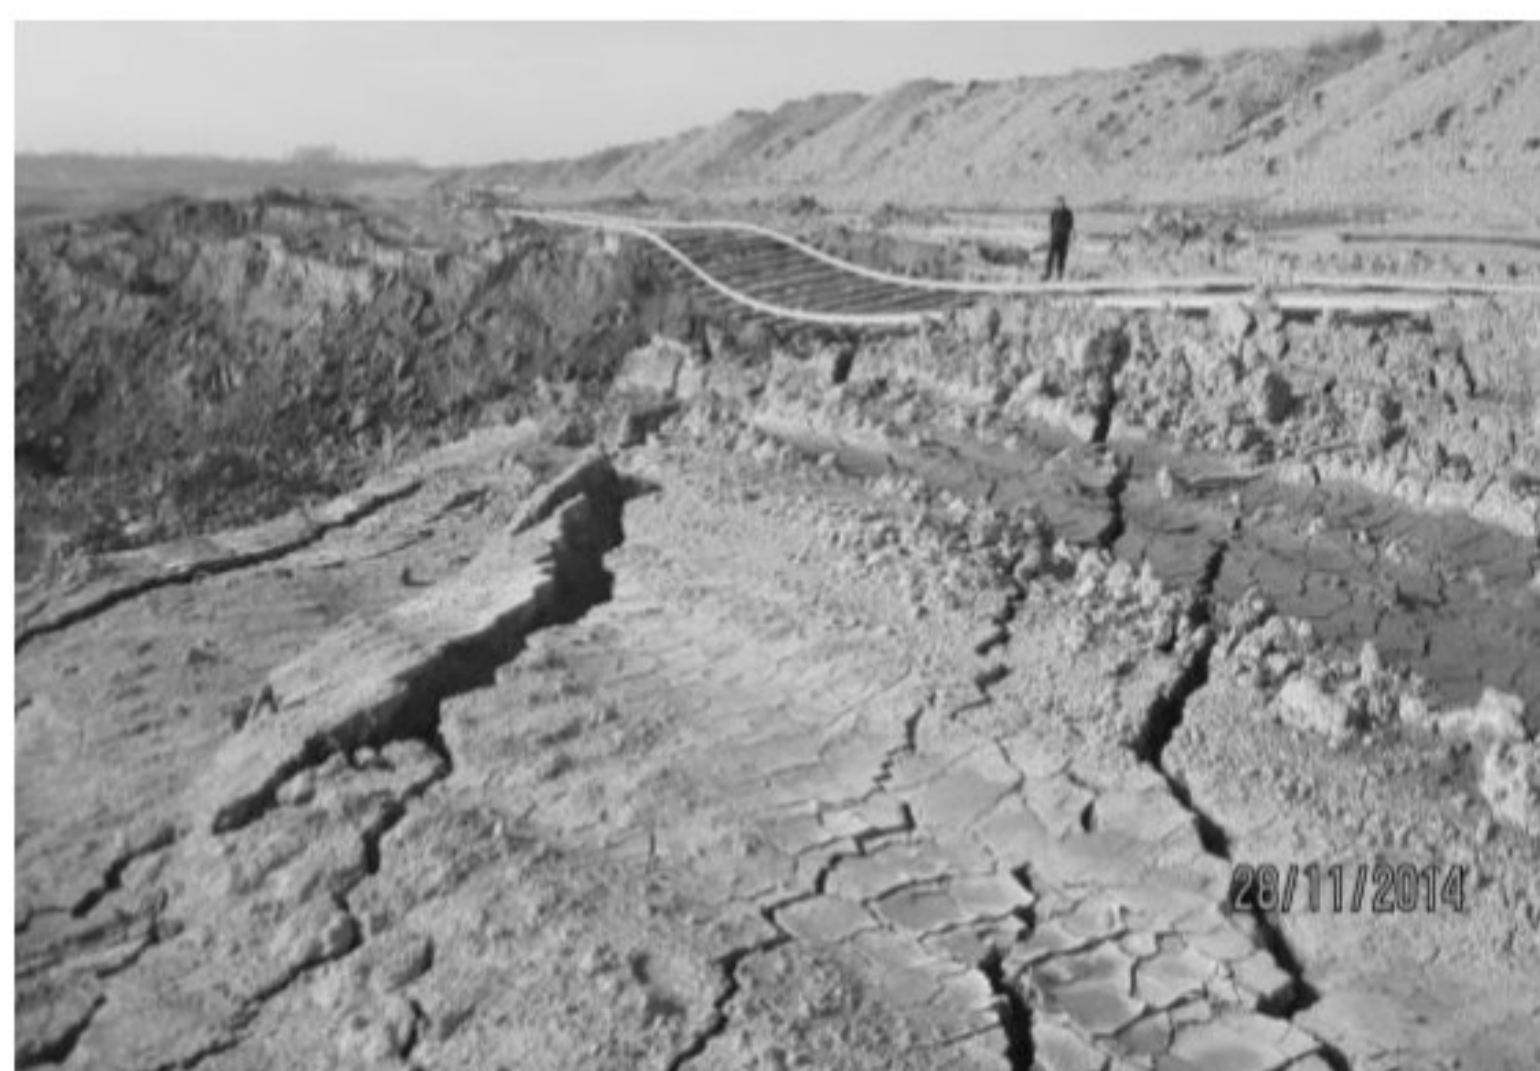
Figure 3, Damage to the O2 transporter and the route of the future Radljevo corridor

Damage to the O2 transporter (2014.) (Figure 3)	Soil compaction, crack filling, terrain drainage and adjustment of belt movement speed and tailings loading, vibration control on conveyors.	Frequent occurrence	Compaction control. It is necessary to devise a method for the quick and uniform consolidation of deposited, fine-grained, non-vibration-resistant soil.	Costs of remediation of conveyors, delay in excavation of tailings (Figure 2).	Worrying
Waterlogging of the forefoot zone of the landfill after pumping out the floodplain lake	Sludge displacement in the east-west direction, towards the lowest elevations on the ground	Rarely recorded for the first time	Better planning protection from the effects of surface flows, more adequate dimensioning of protective embankments and hydroconstruction facilities, as well as better maintenance of existing ones.	The inability to excavate mil. tons of lignite. The problem of lignite exploitation at lower elevations and the safe expansion of landfills.	Acceptable
